UM-3736-98
1998 Acura Integra

In-depth Vehicle Occupant Report

The University
of Michigan
Transportation
Research Institute

Case Vehicle (A): 1998 Acura
 Type: Integra, 2-door coupe
 Driver: 20-year-old male
 CDC: 01-FDEW-2

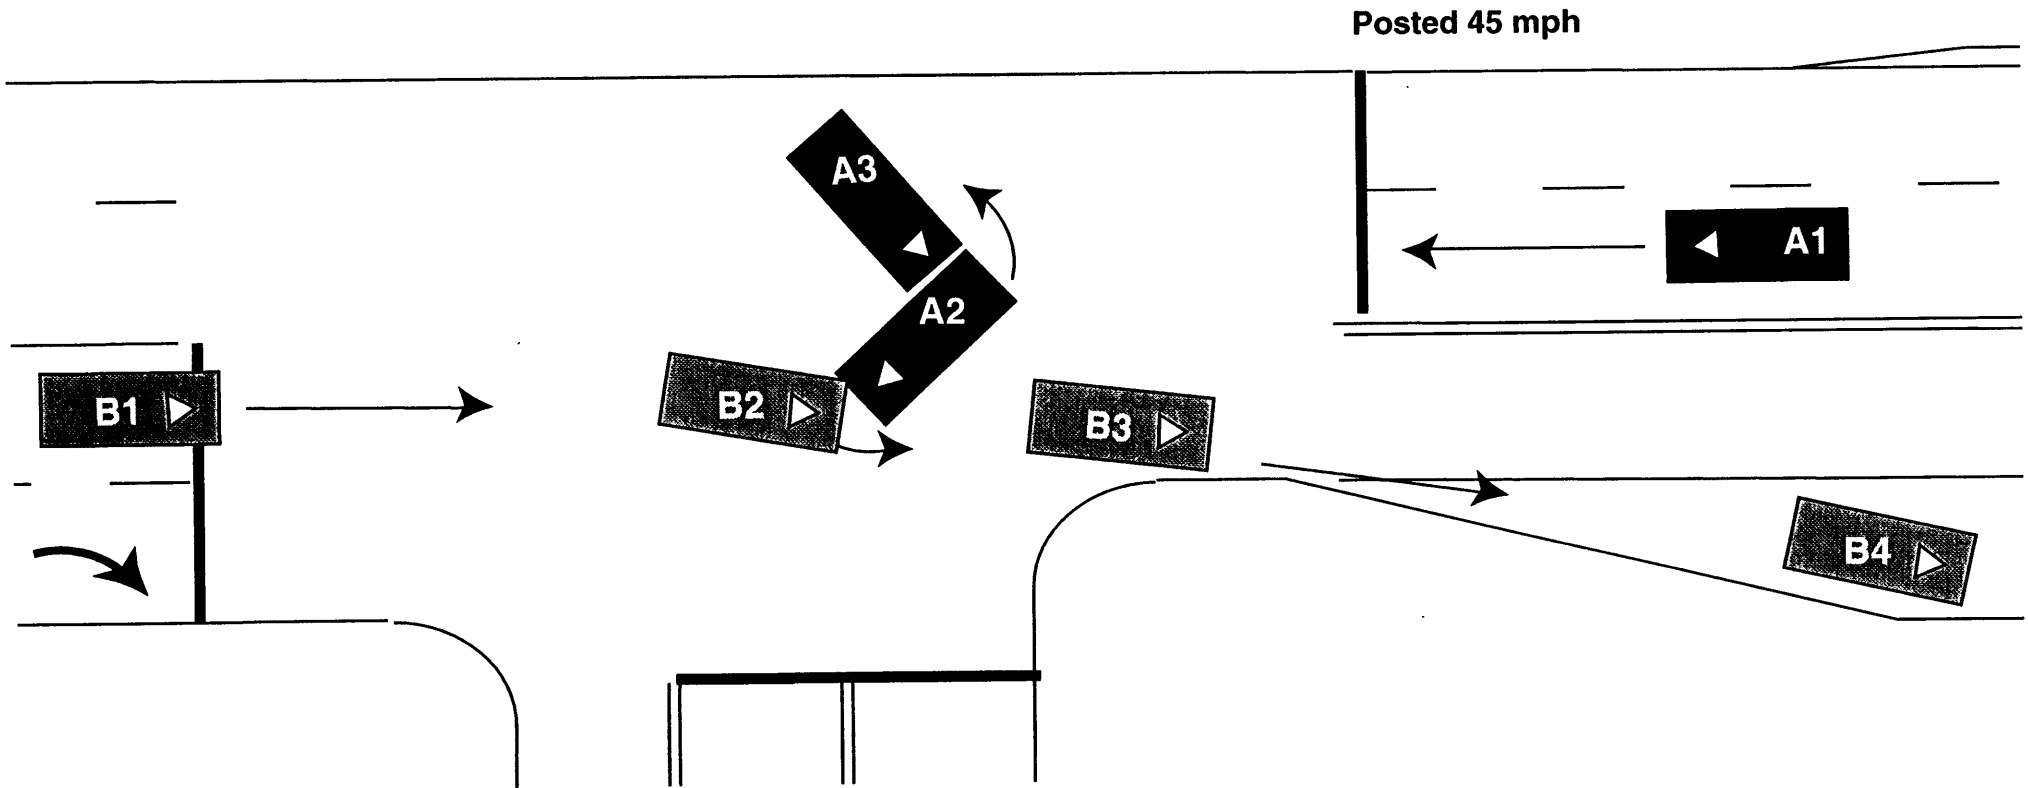
ACCIDENT DESCRIPTION: Case vehicle (A) was stopped at a 3-leg intersection in the southbound left-turn lane. Vehicle (B) was traveling in the inside northbound lane, and entered the intersection, as the driver of case vehicle (A) began a left-turn. The left front of vehicle (B) struck the front of case vehicle (A). Case vehicle (A) underrode vehicle (B), resulting in extensive damage to the bumper and hood. Case vehicle (A) rotated counterclockwise before coming to rest in the intersection, straddling both southbound lanes. Vehicle (B) continued through the intersection and the driver stopped the vehicle on the paved shoulder just beyond the north end of the intersection.

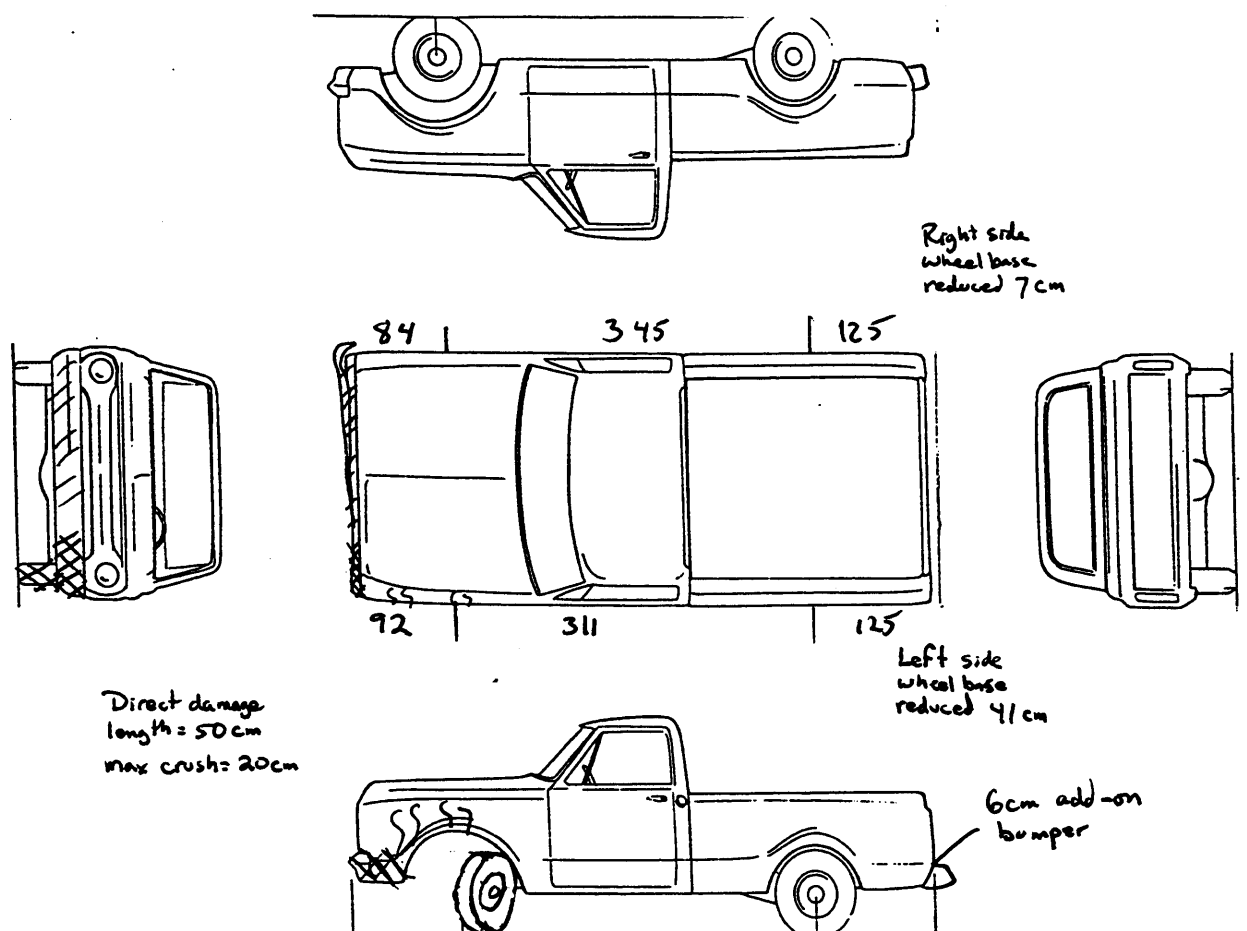
VEHICLE DAMAGE

Damage to vehicle (B) was moderate. The direct damage length was 50 cm, and the maximum crush was 20 cm and occurred at the left-front bumper corner. The left-front wheel was displaced, reducing the wheelbase by 42 cm.

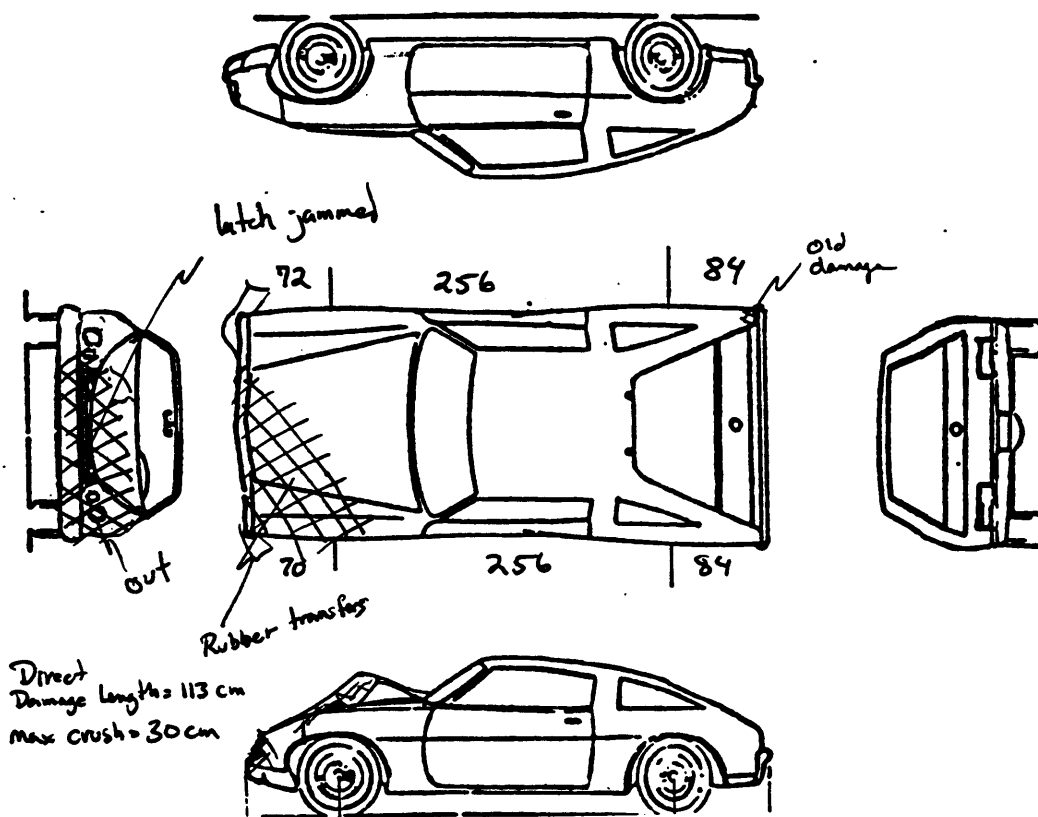
VEHICLE DAMAGE

(Slides 13, 14, 15, 16) Damage to case vehicle (A) was moderate. Direct-damage length was 113 cm and began at the left-front bumper corner. Maximum crush was 30 cm and occurred 68 cm inboard from the left-front bumper corner. The front bumper, headlight assemblies, radiator and both fenders were damaged. The hood was damaged, and the hood latch was jammed. Both hood hinges were damaged, and the left hood hinge was separated from the hood. The rear edge of the hood was elevated, but it did not contact the windshield. Both doors remained closed and operational. There was damage to the windshield from the stress of impact forces.
